Nondestructive Assessment of Wood Members in a Viewing Tower in Potawatomi State Park, Door County, Wisconsin, USA

Research Note
FPL–RN–0366

December
2018

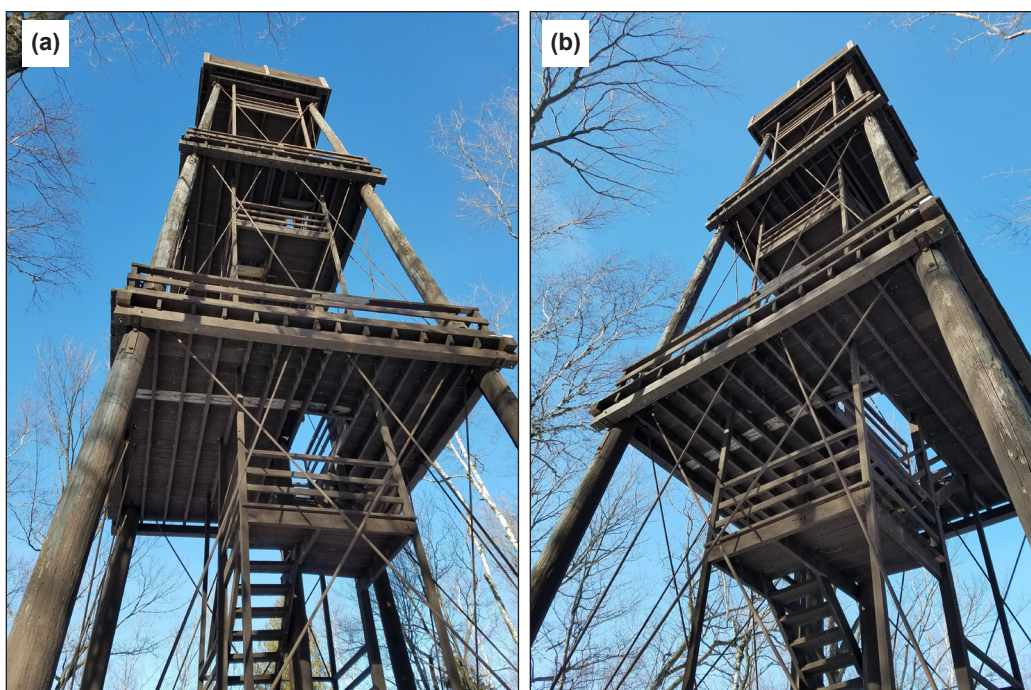
Figure 1. Potawatomi Observation Tower: (a) southwest view; (b) southeast view.

The condition assessment of the Potawatomi Observation Tower was performed on February 6, 2018. Figures 1a and 1b show the tower on the day of the inspection. The assessment began with a visual inspection. Deterioration of structural and nonstructural wood members was evident in the tower. Numerous deep splits and cracks within many of the members, and several deep splits on the main load bearing support columns, were observed. Holes, probably

resulting from nesting activities of birds, were observed. Of concern were splits and deterioration in the vicinity of connections and the evidence of lateral movement of the upper sections of the tower.

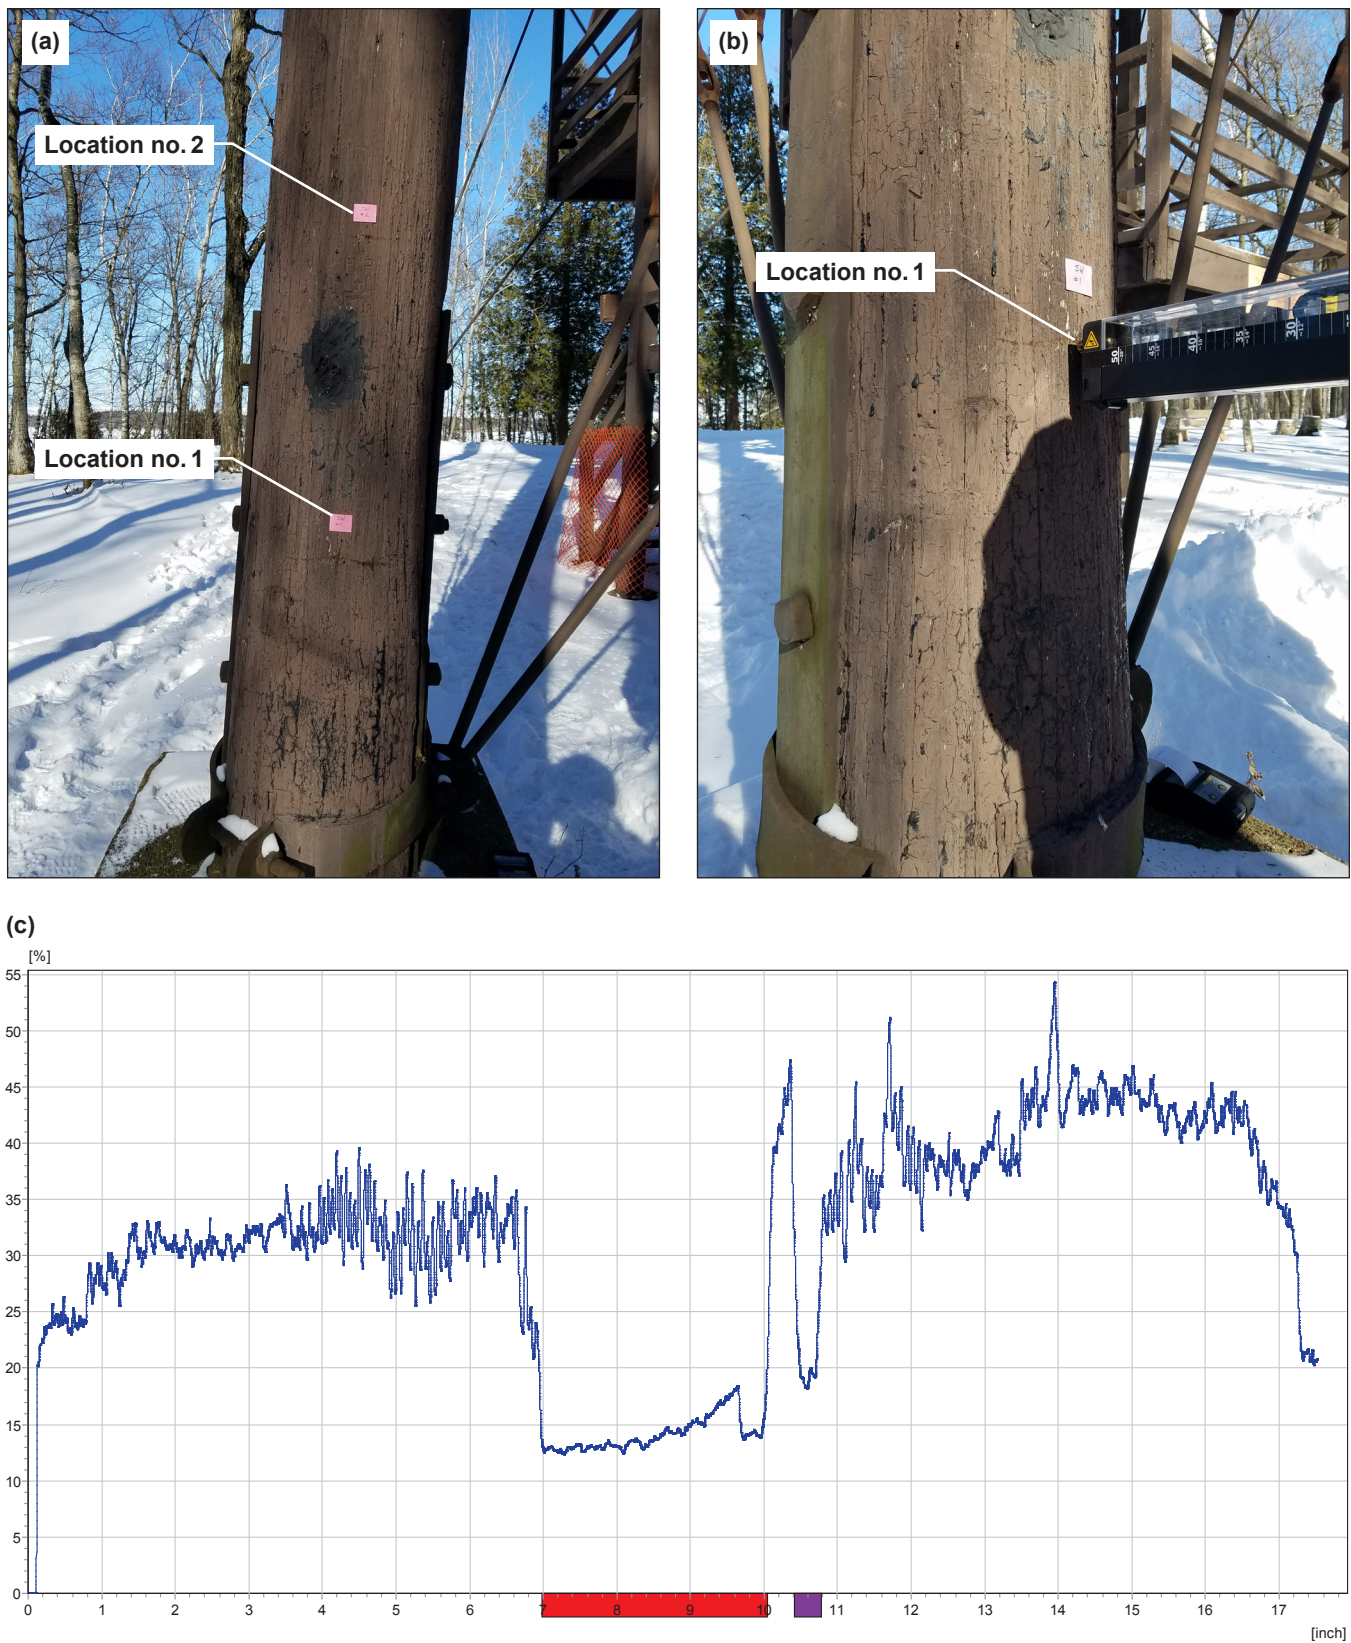
After the visual inspection was completed, sound transmission and micro-resistance drilling tests were performed. Figure 2a shows the southwest tower support pole near ground level. Note the large patched area sealing a previous woodpecker hole. Similar patches were present on all four support legs of the tower. The pink attached notes indicate sites where micro-resistance drilling inspections were performed. Figure 2b shows the resistance drilling tool positioned for use, and Figure 2c shows the results of the inspection. The diameter of the pole at the inspection site was 17 in. The measured resistance noticeably decreases between approximately 7 and 10 in. from the edge. The decrease indicates the presence of interior decay or a void, or both.

Figure 2. Southwest support pole at ground level. (a) View of southern side of support. The attached pink notes indicate locations of micro-resistance drilling test. The black patch is the location of a sealed woodpecker hole. (b) Micro-resistance drilling test at location no. 1, 32 in. above the footing. (c) Resistance profile for location no. 1 reveals a 3- to 4-in. center deterioration, which was likely caused by water entering through the woodpecker hole 1 ft above.

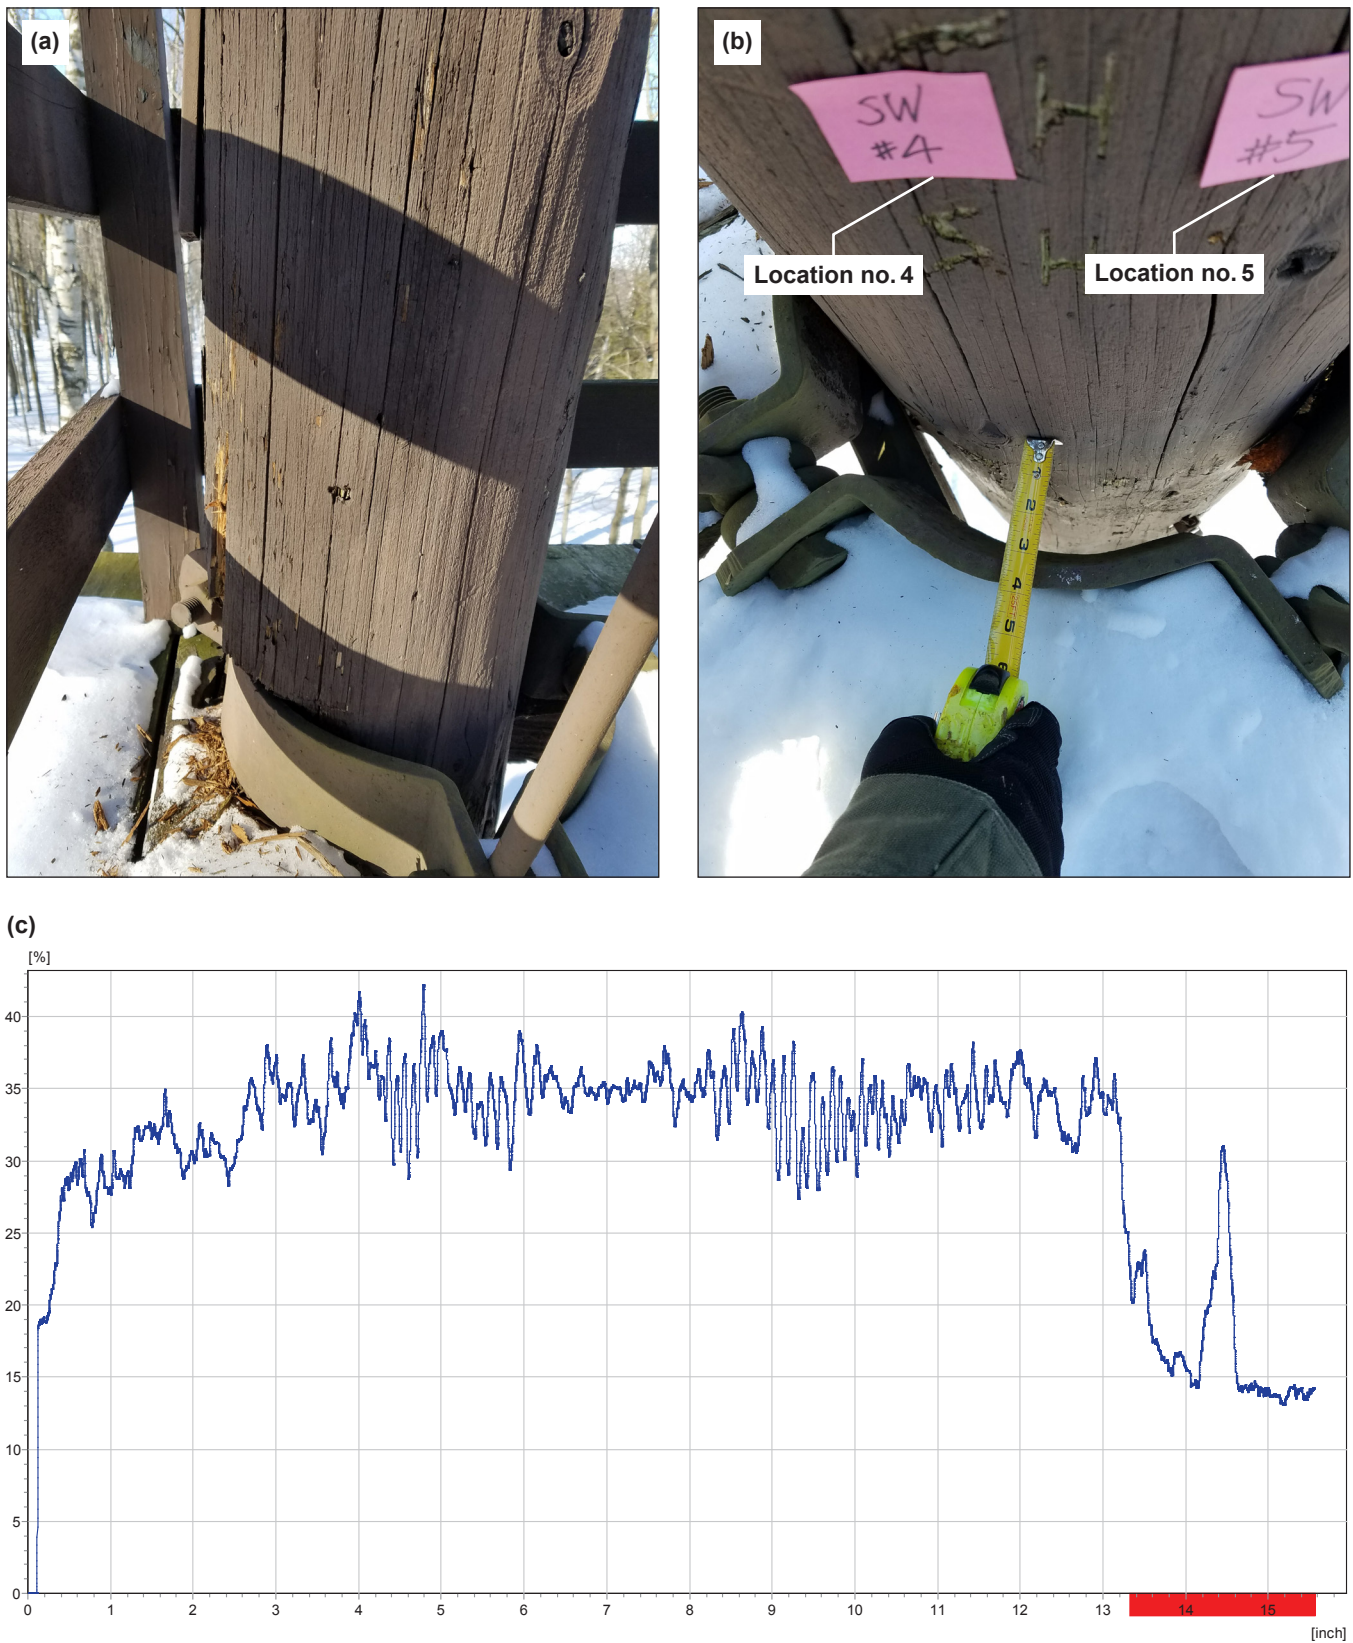
Figure 3a shows the steel collar securing the first platform to the southwest support. The steel collar had displaced relative to the location of the support approximately 3-1/4 in., causing noticeable damage (Fig. 3b). The displacement was sufficiently deep to completely penetrate through the surface preservative treatment. Figure 3a also shows surface deterioration on the south side of the support. The wood at that location was easily penetrated by a probe with minimal effort, indicating the presence of advanced decay. Figure 3c shows the results of the micro-resistance drilling at location no. 5, 10 in. above the steel collar (as shown in Fig. 3b). The resistance profile showed sign of decay for the outer 1-1/2 in. in this location.

Figure 3. Southwest support pole at platform 1. (a) Steel collar securing the first platform to the southwest support. Displacement of the collar has damaged the support and penetrated the surface layer of preservative. Deterioration is apparent where the clamp has damaged the support. (b) Steel clamp has displaced 3-1/4 in. The attached pink notes show micro-resistance drilling locations no. 4 and no. 5, 10 in. above the collar. (c) Resistance profile for location no. 5 shows 1-1/2 in. of surface decay.

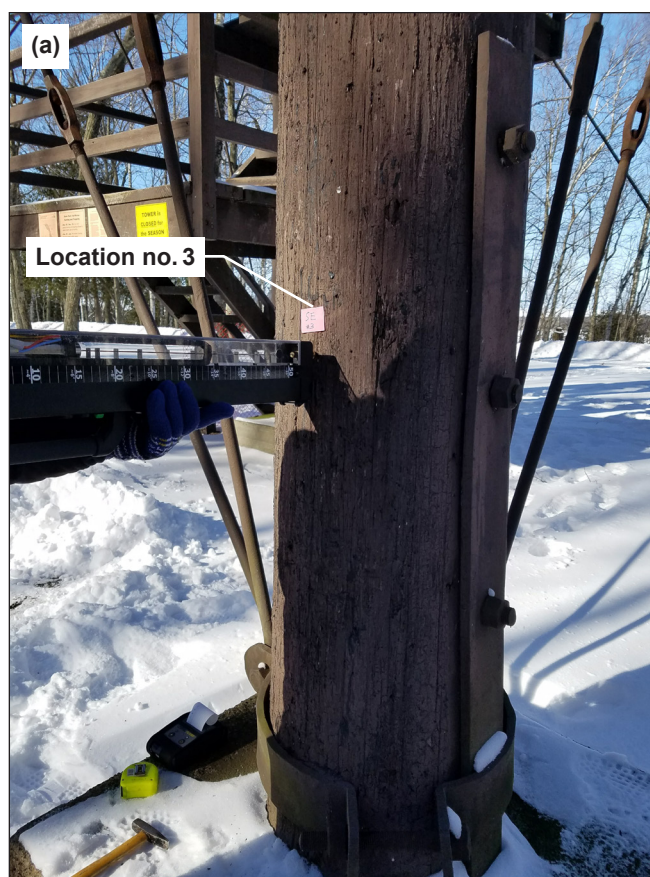
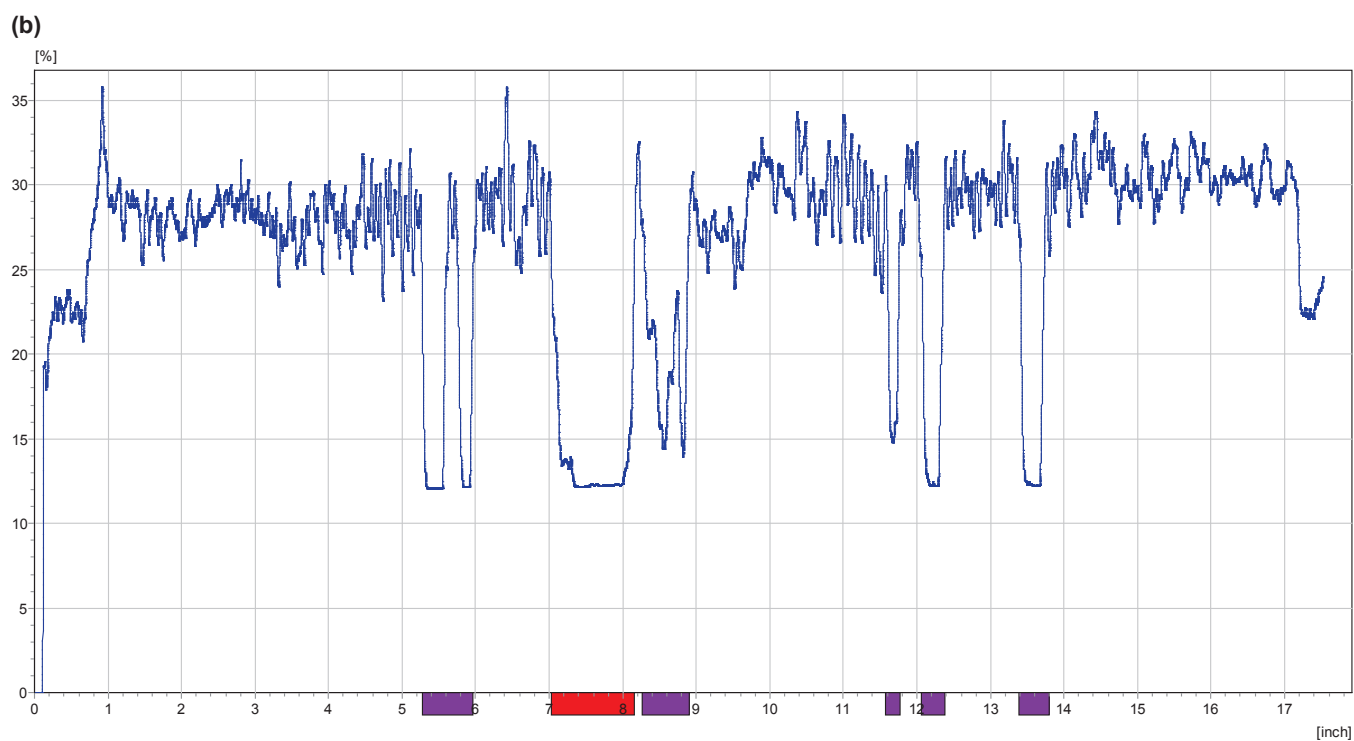
Figure 4a shows the southeast support of the tower. The diameter of the support pole at the location shown is 17 in. Micro-resistance drilling at location no. 3 is 37 in. above the footing. The resistance profile shown in Figure 4b reveals center decay of 1 in. diameter and multiple internal cracks.

Figure 4. Southeast support pole at ground level. (a) Micro-resistance drilling test at location no. 3, 37 in. above the footing. The support diameter is 17 in. at this location. (b) The resistance profile reveals center deterioration (marked red) of 1 in. diameter and multiple internal cracks (marked purple).

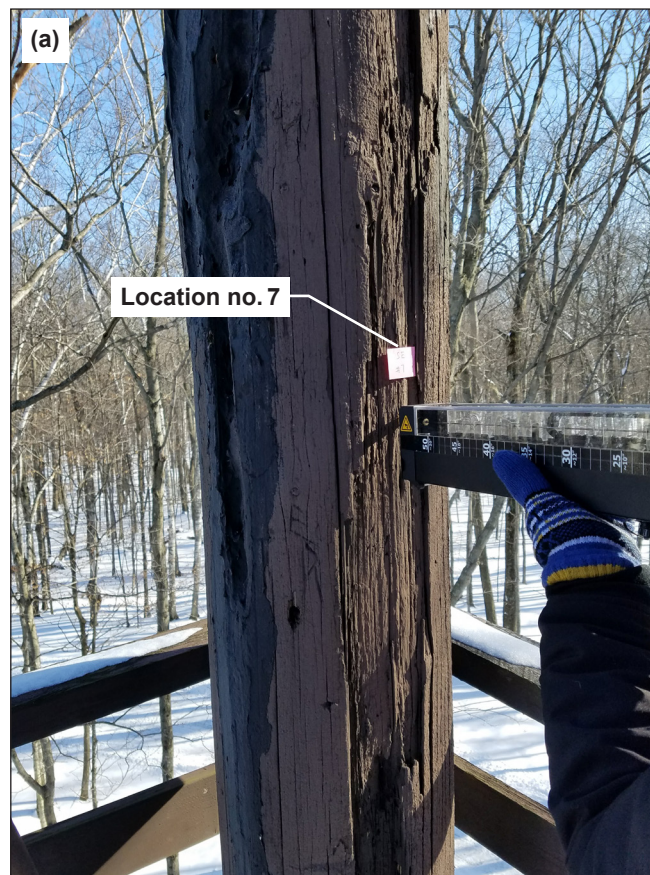
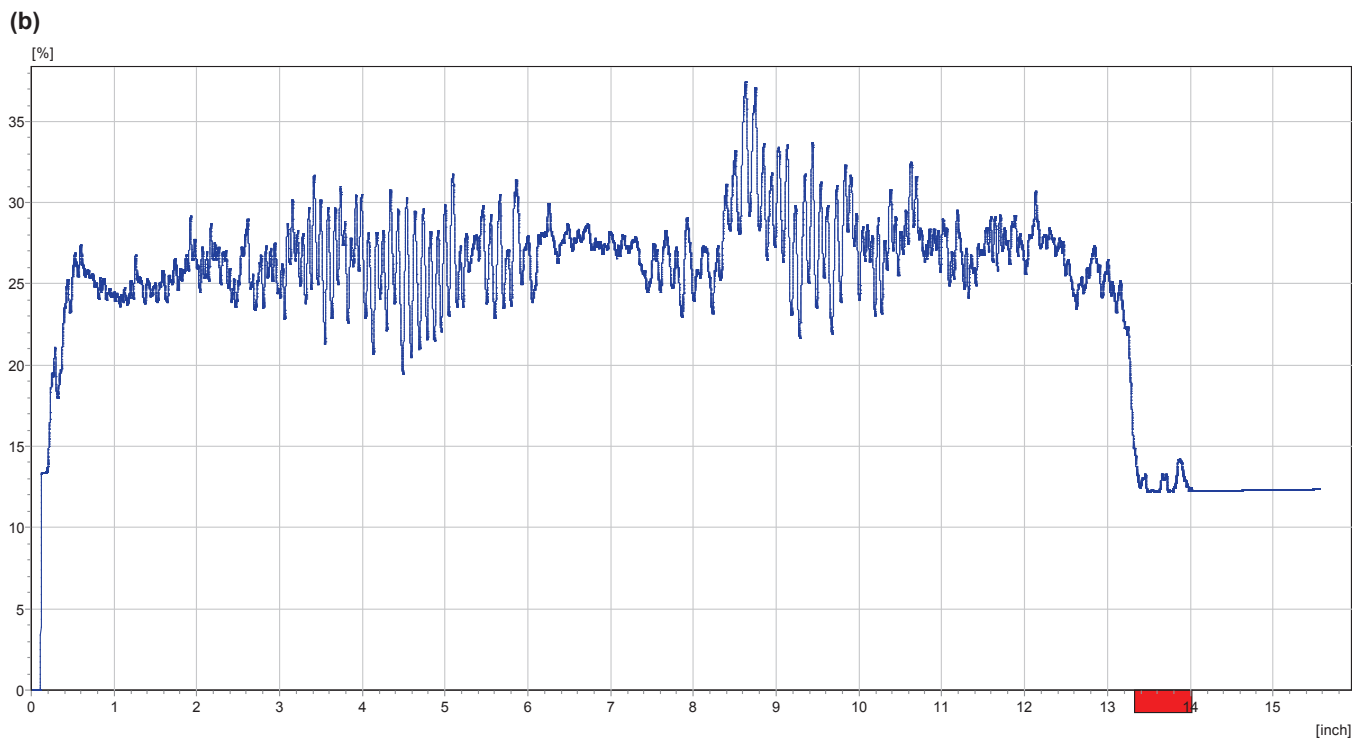
Figure 5a shows the southeast support pole at the first platform. Micro-resistance drilling was performed at location no. 7, 58 in. above the platform, where the diameter of the support pole was 15 in. Large patched cracks of unknown depth are observed on this timber. The resistance profile results shown in Figure 5b reveal an internally sound support with some surface deterioration (marked red in the resistance profile).

Figure 5. Southeast support pole at platform 1. (a) Micro-resistance drilling test at location no. 7, 58 in. above the platform. The support diameter is 15 in. Large patched cracks of unknown depth can be observed on this timber. (b) The resistance profile reveals an internally sound support with surface deterioration.

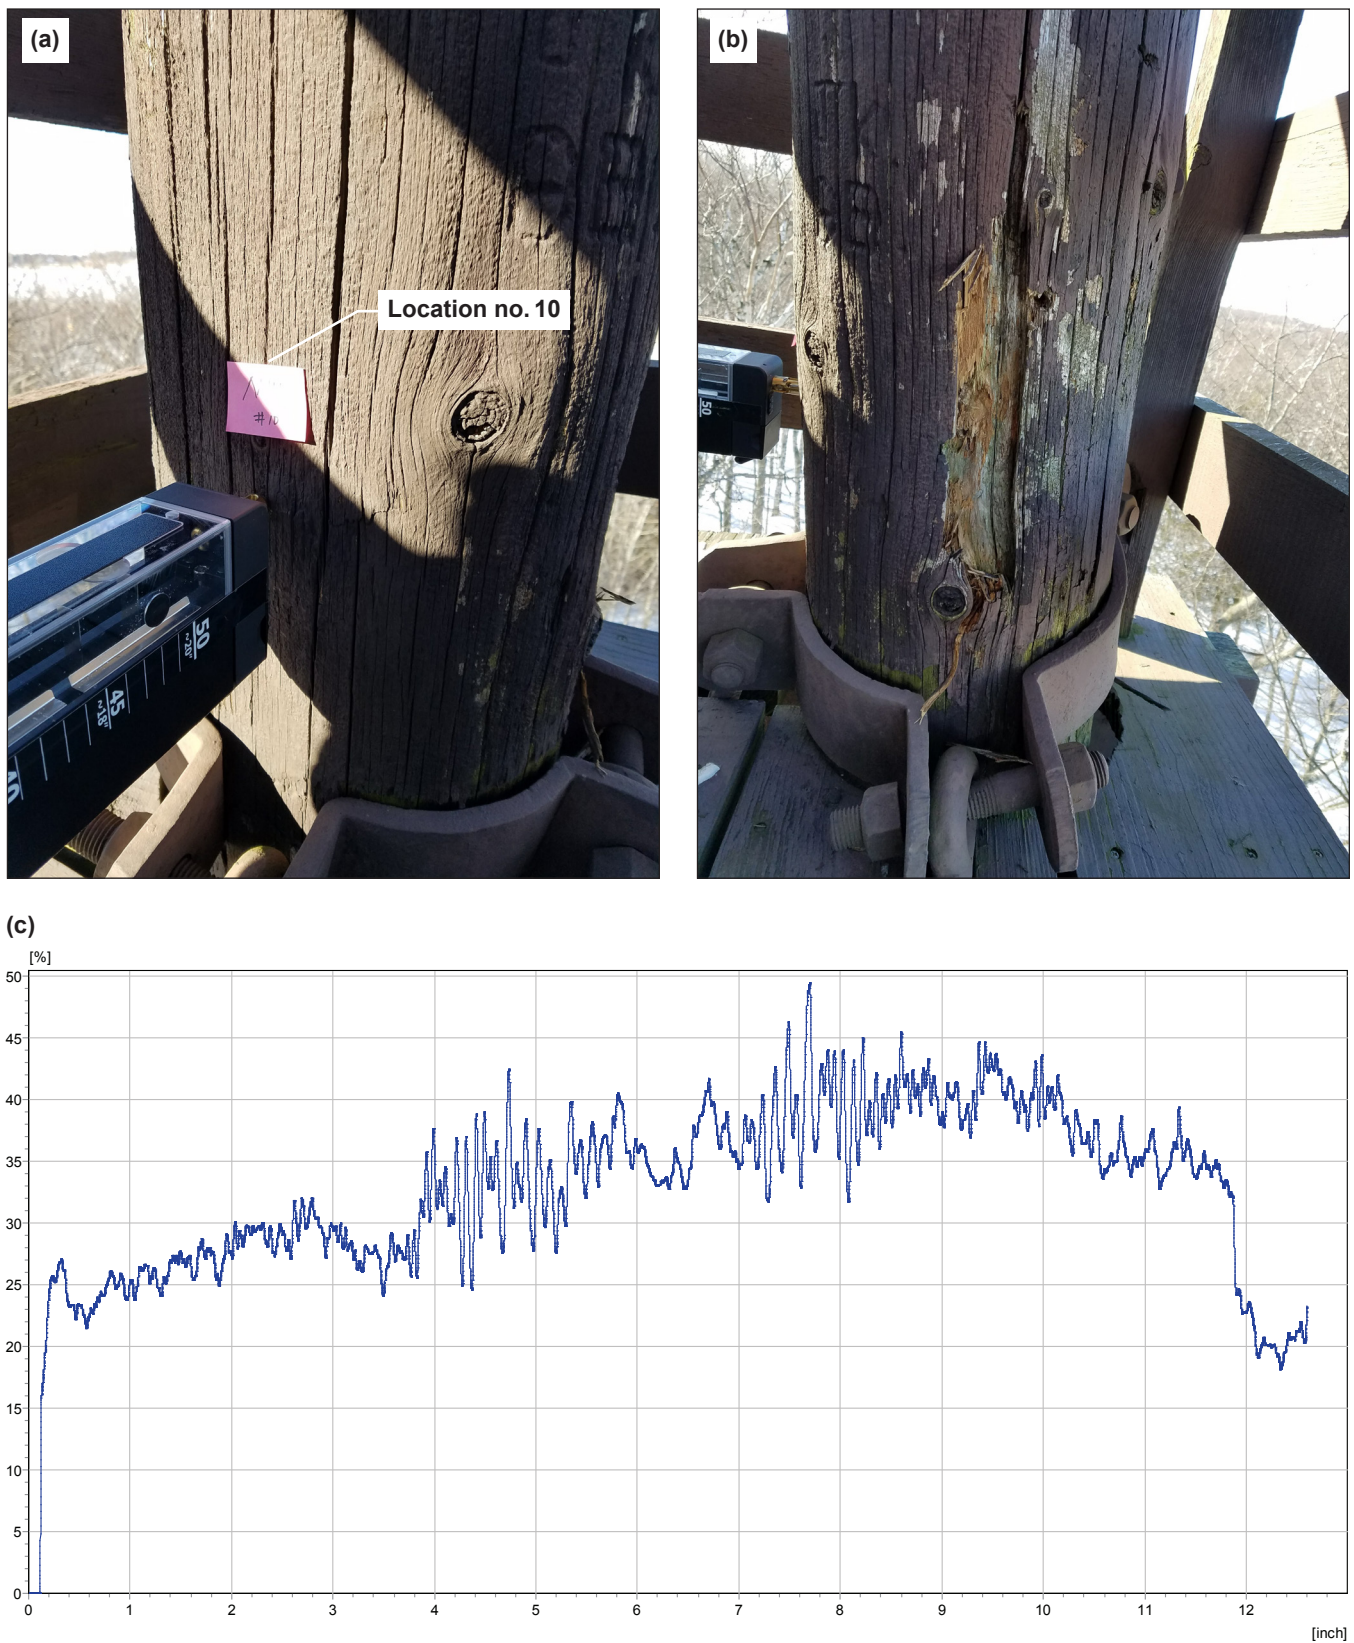
Figure 6a shows the northwest support pole at the second platform. Micro-resistance drilling was performed at location no. 10, where the support pole diameter was 12 in. Figure 6b shows visible surface deterioration on the east side of the support. The resistance profile shown in Figure 6c reveals an internally sound support.

Figure 6. Northwest support pole at platform 2. (a) Micro-resistance drilling test at location no. 10. (b) Visible surface deterioration. (c) Resistance profile reveals an internally sound support.

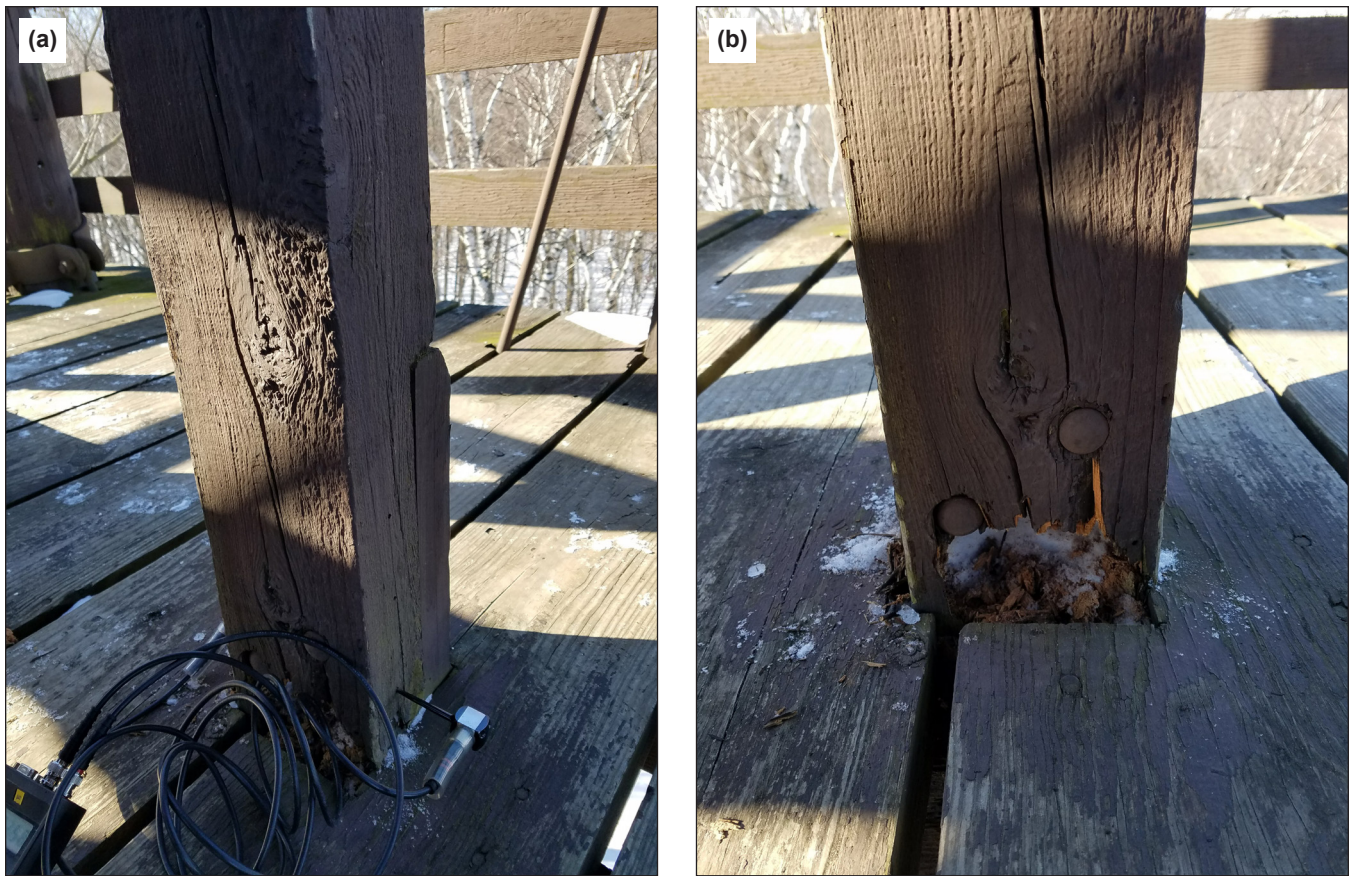
Figure 7 shows the central rectangular timber supporting the staircase at the second platform. The stress wave timing tool is shown in Figure 7a. Results of the stress wave timing

measurement were significantly high. Any measurement of greater than 300 μ s/ft is indicative of internal decay. The measurement across the support was 853 μ s/ft, indicating severe decay. In addition, Figure 7b shows visible decay. The extent of the decay on the support was such that the wood could be removed by hand with little to no effort.

Figure 7. Central stairway support at platform 2. (a) Stress wave timing measurement showed significantly high readings (426 μ s, equivalent to 853 μ s/ft), indicating severe decay. (b) Visible deteriorated wood.
